TOOLBOX TALK #37

CRANE COLLAPSE ACCIDENT

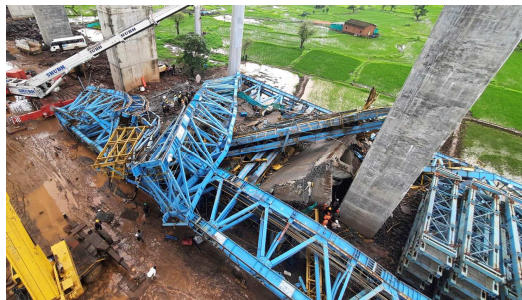
Before moving on to attempt another pile driving, the employees had to retrieve a piece of equipment out of the ground with the crane. The crane's boom, however, wasn't configured according to the manufacturer's specifications. A 40-ft section was in the wrong place.

OSHA's safety engineer said the company chose not to reconfigure the crane to save time and money. The company's owner said he used this configuration multiple times and never encountered any problems. He believed his configuration would be as good as the manufacturer's. He was wrong. Putting the 40-ft section in the wrong spot made the crane boom weaker and vulnerable to collapse.

Additionally, the company miscalculated – by nearly 5000 pounds – the weight the crane was trying to lift. Further, the employees were trying to “side pull” a load instead of lifting it straight up, a technique that is prohibited by the American Society of Mechanical Engineers (ASME). The side-pulling, the miscalculated weight and the misconfigured crane boom all contributed to the deadly collapse.

- Always follow safety instructions from the manufacturer's operation manual, including crane assembly. Contact the manufacturer for consultation, if needed.
- Properly calculate the weight being lifted and only pick up objects that are directly under the crane boom – no side pulling.
- Remember that even if you perform a task multiple times without incident, that doesn't mean it's a safe operation.
- Always follow OSHA and industry-recognized standards.
