TOOLBOX TALK #40

WORKER DIES AFTER FALLING FROM SCAFFOLD

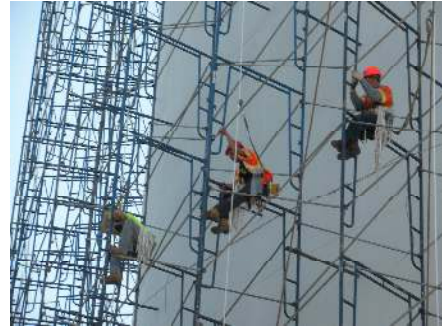
A 46-year-old owner of a residential siding company died from injuries sustained from a 20- to 25-foot fall onto a concrete slab. On the day of the incident, a subcontractor was installing siding in a breezeway. To work around concrete stairs and other structures, workers used only one pump jack pole and the stair landing to support the other end of the platform. To raise the platform above landing height, the workers placed a stepladder on the landing and raised the pump jack pole on the other side. The victim was attempting to use a second stepladder placed on top of the scaffold platform when he fell. He died the next day.

- *Evaluate site-specific conditions to determine the most appropriate means of safely accessing the work area*
- *Require and ensure the use of fall protection*
- *Establish a program that includes provisions for qualified persons to conduct regular and frequent inspections*
- *Develop a site-specific safety plan that addresses conditions that may affect safety or safety equipment*
- *Encourage workers to voice concerns about unsafe conditions*
- *Don't take shortcuts*
