TOOLBOX TALK #43

MACHINIST DIES BEING PULLED INTO LATHE

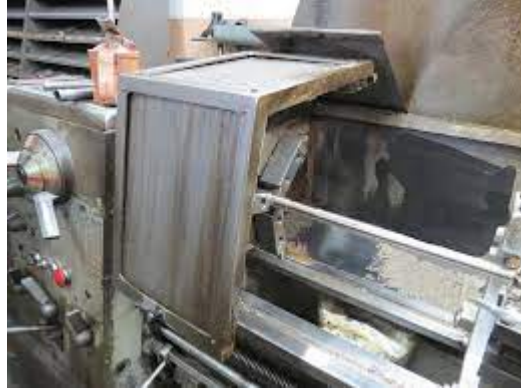
A 52-year-old machinist at a manufacturing company was preparing to spot-drill the center of a 103-inch piece of round steel in a manual lathe. Because of the length of the steel, 24 inches of the material was protruding out of the back of the unguarded lathe, held in place with an aftermarket clamping device that rotates as the lathe rotates.

Security footage showed that while the lathe was in operation and the steel rod was spinning, the machinist attempted to grab a glove from the top of the lathe. The sleeve of his shirt became entangled on the clamping device, pulling him into the lathe between the motor and rotating piece of steel.

As the lathe continued to turn, the machinist's body rotated around the piece of steel and struck the motor about 12 times. An employee in the changing room heard the event, ran out to investigate, shut down the machine and called emergency medical services. First responders transported the partially-conscious machinist to the hospital, where he was pronounced dead on arrival. Cause of death was listed as traumatic blunt force injuries.

- Fabricate or purchase guarding and affix it to machines to protect operators from rotating components.
- Mark "No Entry Areas" clearly and provide applicable training.
- Prohibit machine operators from wearing loose-fitting clothing while operating lathes.
- Consider implementing a job hazard analysis procedure.
- Regularly provide hazard awareness training to employees.
